SUBJECT: Site Inspection, UMETCO, Wilson-Silverbell Mine, M/037/027, San Juan County, Utah

Date of Inspection: July 1, 2004
Time of Inspection: About 11:10 a.m. to 12:15 p.m.
Conditions: Mostly clear, 80's
Participants: Rahe Junge and Frank Barnett, UMETCO; Paul Baker, DOGM

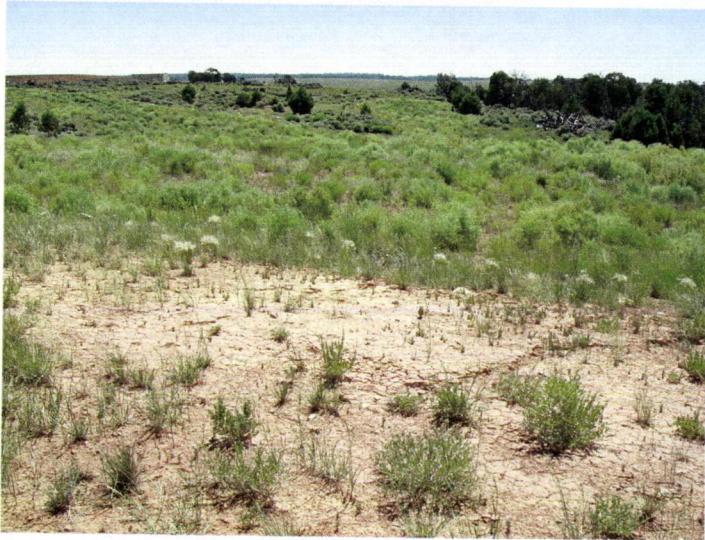
The waste pile at Silverbell was apparently planted at the same time and using the same methods as at Wilson, but the results are much different. Photo 4 is typical of the site although there are a few places (Photo 5) with less cover.

Photo 5. An area on the south side of the Silverbell pile. There are a few bare areas like this with some minor erosion,.

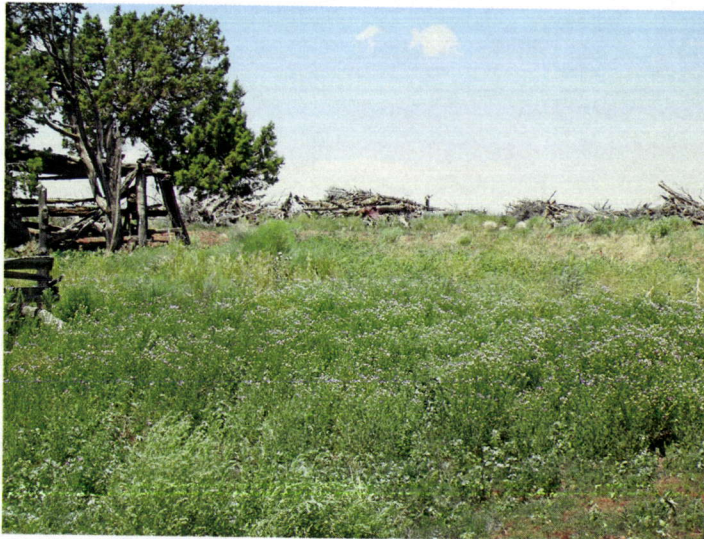
The operator has been working to control Russian knapweed, and while this has been mostly successful, there are still a few patches (Photo 6) within the mine area and on adjacent land.

Photo 6. Russian knapweed.

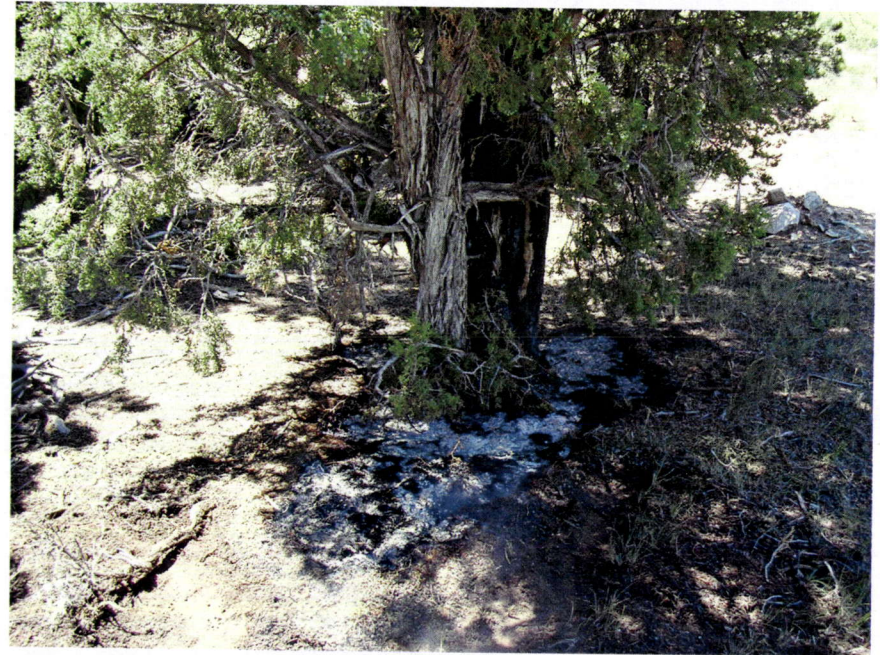
While we were walking around the site, we noticed the smell of smoke and wondered if smoke was drifting in from some of the wildfires to the south and west. We then noticed a nearby juniper (Photo 7) that had been struck by lightning. The organic duff below the tree was smoldering with a little flame occasionally. Mr. Junge and Barnett were going to put it out after I left.

Photo 7. A juniper that was hit by lightning with some of the burned soil around it.
